***IN-SITU TESTS OF THREE
BENTS AT SOUTH TEMPLE
BRIDGE ON INTERSTATE 15 –
FINAL REPORT***

**Civil & Environmental
Engineering Department
University of Utah
Salt Lake City, Utah**

**Utah Department of Transportation
Research Division**

June 2003

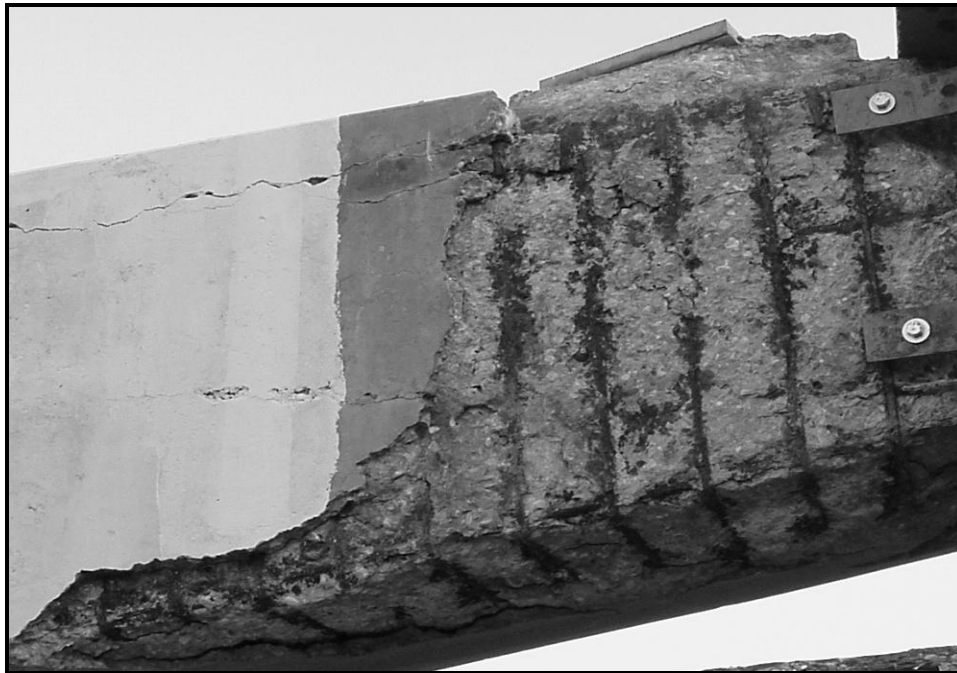
The general condition of Bent #4S in the spring of 2000 was as follows: the vertical columns had very minor cracking and hardly any spalling, and the horizontal cap beam had practically lost its clear cover. There had been severe spalling on various sections of the 37 year old structure due to concrete degradation brought on by rebar corrosion/expansion and freeze/thaw action. Although the significant spalling appeared to be restricted to the cap beam on the bottom face between the columns and the three vertical faces of both tapered ends, the entire cap beam vertical faces had many hollow sounding spots that rendered the clear cover of the cap beam useless. These areas of the cap beam also revealed longitudinal and transverse reinforcement that had been severely weathered. The columns, strut-beams and pile caps were all clean and intact. Photographs of spalling are provided in Figures 2.5, 2.6, and 2.7. Clearly, the state of the cap beam was in serious deterioration; more details for an in-depth study of the impact of the corrosion on the shear capacity can be found in the study for the northbound bridge tests carried out in 1998 (Pantelides et al. 2000).

Figure 2.6 Spalling due to reinforcement deterioration on cap beam of Bent #4S

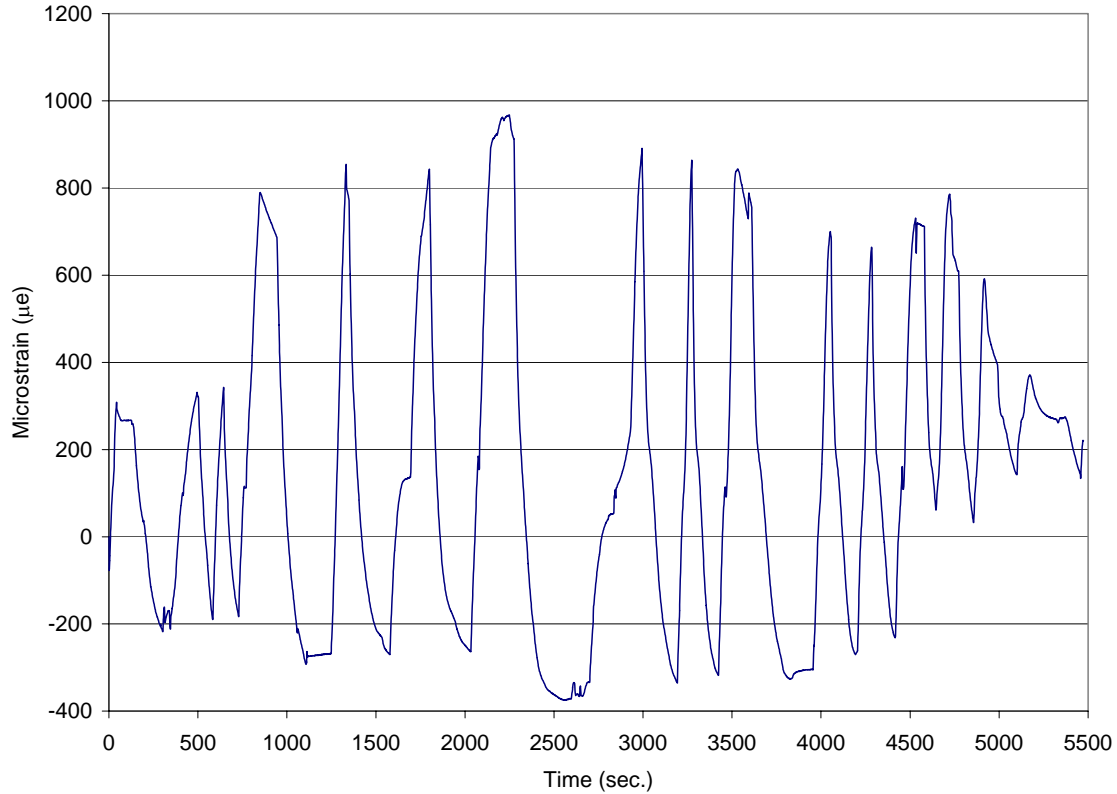
Figure 2.35 Strain gage SG33 showing reduction of strain due to bar pullout

Six strain gages numbered SG29, SG30, SG31, SG32, SG33, and SG34, were placed in Zone 1 as shown in Figure 2.22. The maximum tensile strain recorded in these strain gages was $1640\mu\epsilon$ which is 136% of yield for SG 32, $1400\mu\epsilon$ or 116% yield for SG31 and SG33 was $960\mu\epsilon$ or 80% of yielding strain. The maximum compressive strain for SG32 was $719\mu\epsilon$ or 60% of yield, SG31 produced 19% of yield strength at $226\mu\epsilon$, and SG33 has a strain of $372\mu\epsilon$ or 31% of yielding strain. Strain data given by SG33, and SG34 show a trend in that the strain builds as each progressive drift is achieved without yielding until in the 8th cycle in the 1.5% drift step. From that point on, the strain gage records a reducing strain reading as is seen in Figure 2.35. This is indicative of the mechanism of de-bonding or pullout.

Strain gages SG33 and SG34 were located on the north face of the cap beam on the upper and lower rebar. The north and south faces of the bent cap were particularly corroded; in many areas the rebar was actually visible due to the missing concrete clear cover. It is then easy to see why these bars will debond at low drift levels.

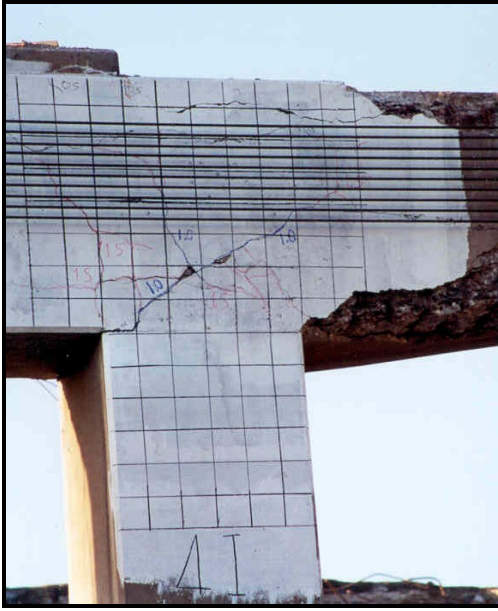
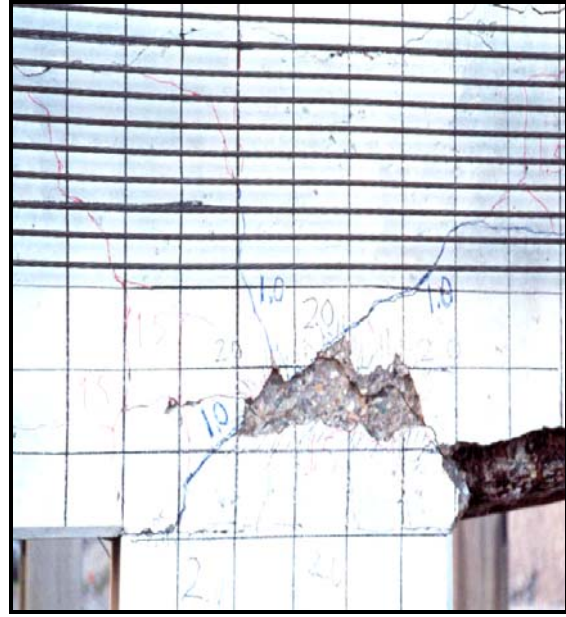
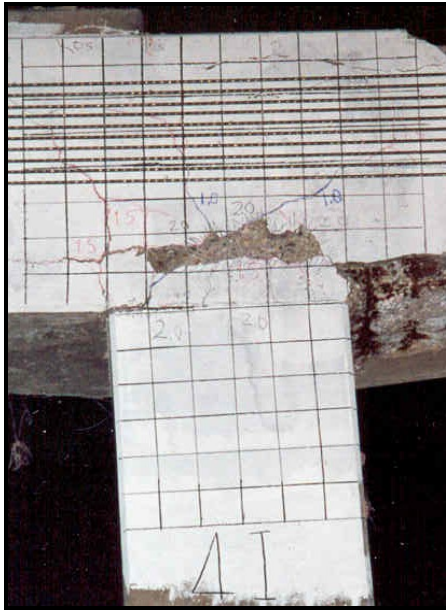
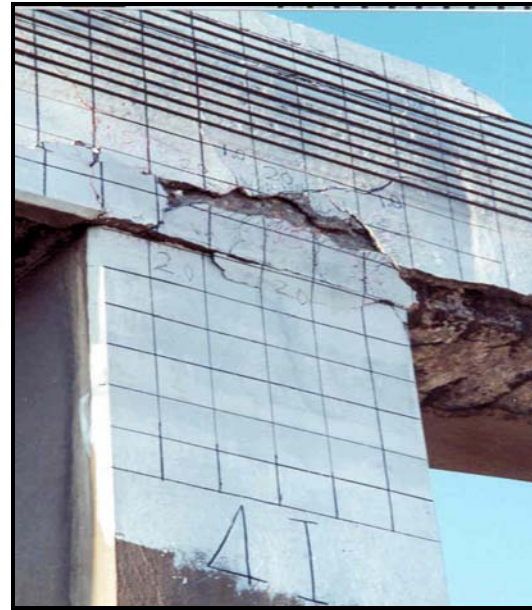
Figure 2.37 Condition of East column-bent cap joint: (a) 1.5% drift, (b) 2% drift, (c) 4% drift, (d) 5% drift

- 1.) 0.2mm cracks @ 0.5% drift
- 2.) 1.0mm shear crack developing @ 1.0% drift
- 3.) 3.0mm diagonal shear cracks @ 1.5% drift, no flexural cracks have developed at the top of the column, which would be expected, plastic hinge is observed to form approximately 279mm above column in the cap beam
- 4.) 4.0mm diagonal shear cracks, and $185\text{mm}^2 \times 25\text{mm}$ spalling along column/cap-beam interface @ 2.0% drift
- 5.) 5.0mm cracks @ 3.5% drift
- 6.) Two main diagonal shear cracks reach 1.24m and 1.11m in length by 5.0% drift and measure 6.5mm wide with the majority of the clear cover de-bonded, but still hanging, still no flexural cracks at top of column. Pure pin has formed in the cap beam

After removing the de-bonded clear cover, the column longitudinal reinforcement was found to end 355mm below the top of the Cap beam, and that all of the bars on the south face had pulled out with an average of 16mm. The plans called for a splice piece to be attached to each of the vertical bars, but apparently it was neglected. If early pullout has occurred it makes sense as to why no flexural cracks developed at the top of the column.

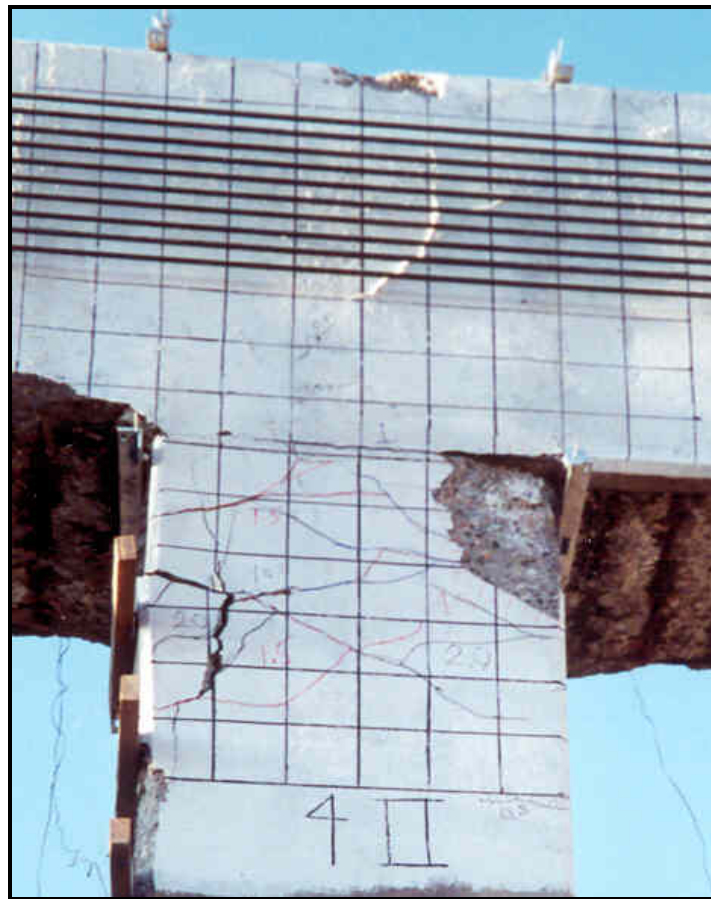
Figure 2.40 Damage to Center column-bent cap joint at the end of 5% drift

After removing the de-bonded clear cover, the column longitudinal reinforcement on the east and west faces were found to have buckled. The buckling on the west face was displaced 90mm out. The east face buckling was less severe, only 12mm. The main buckled area was approximately 304mm below the cap/column cold joint as seen in Figure 2.40. Figures 2.41 and 2.42 show the column rebar buckling which occurred mainly on the west face.

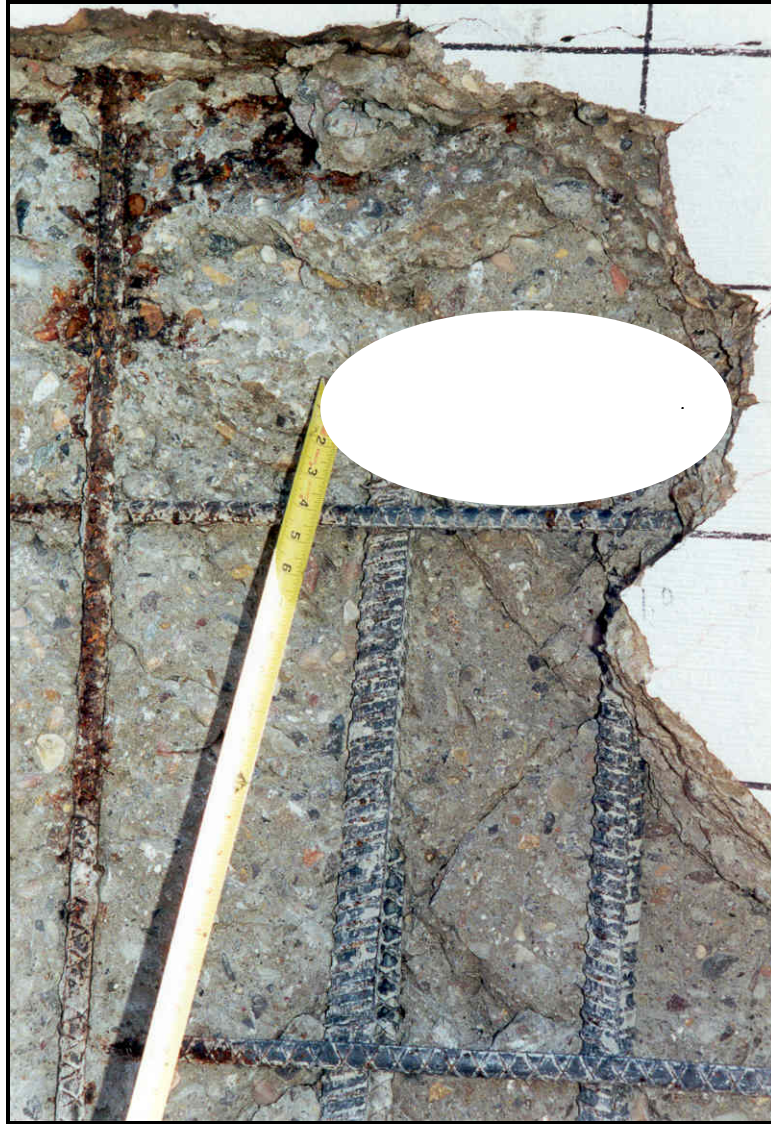
Figure 2.46 Pullout pocket in column longitudinal bar in West column-bent cap joint; the pocket is 22mm long

Six strain gages numbered SG65, SG66, SG67, SG68, SG69, and SG70 were placed in Zone 3 as shown in Figure 2.22. The maximum tensile strain recorded out of these strain gages was $2340\mu\epsilon$, which is 195% of yield in SG 68 located at the top of the west column on the east face just below the cap beam. The maximum compressive strain found in SG67 was $1400\mu\epsilon$, or 116% yield. Strain data given by SG65 and SG66 located on the cap beam south face and attached to the top and bottom longitudinal bars, show very similar results to SG33 and SG34 located in the mirror position on the east column. The time history of SG65 is shown in Figure 2.43. Figure 2.43 shows that SG65 has the same tendency of the rebar to lose strain with larger displacement; it reached yield in the tension phase of the 5th cycle at 2% drift, and yielding each subsequent cycle in tension up to $1550\mu\epsilon$, after which the strain drops off indicating that the bar has de-bonded. SG69 and SG70 similarly loose strain starting slowly around 1.5% and totally lose strain by the end of 2.5% drift, as shown in Figures 2.44 and 2.45. Gages SG69 and SG70 were attached to the center longitudinal rebar in the west column. As this particular rebar is near the neutral axis of the column, when the cycles change between push and pull the rebar always shows a tensile strain. The graphs therefore always stay above the x-axis. The drop in tensile strain correlates to insufficient embedment and premature pullout, which is visually verified by the 22mm pocket located at the top end of the rebar located 0.355m from the top of the bent cap, which can be seen in Figure 2.46.

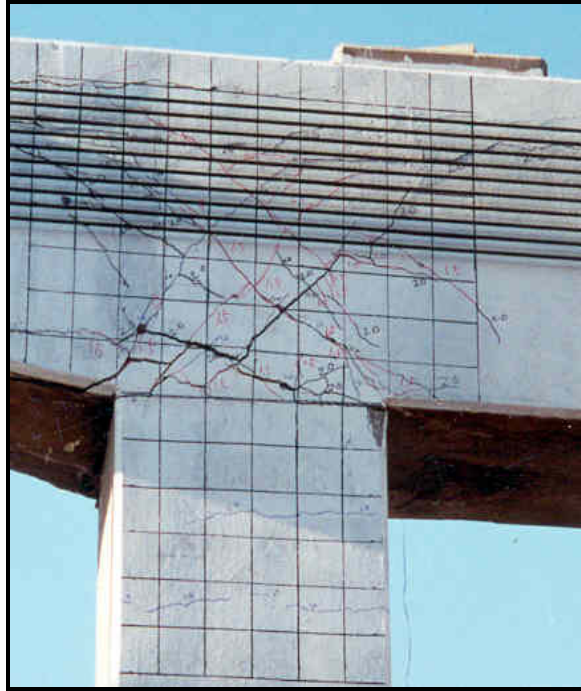
Figure 2.49 West column-bent cap joint at 5% drift ratio

- 5.) South face of west column /bent cap joint has largest 14mm open crack, east face largest crack is 3.0mm, north face largest crack is 7.0mm, west face largest crack is 3.0mm; heavy shear damage and a well developed plastic hinge

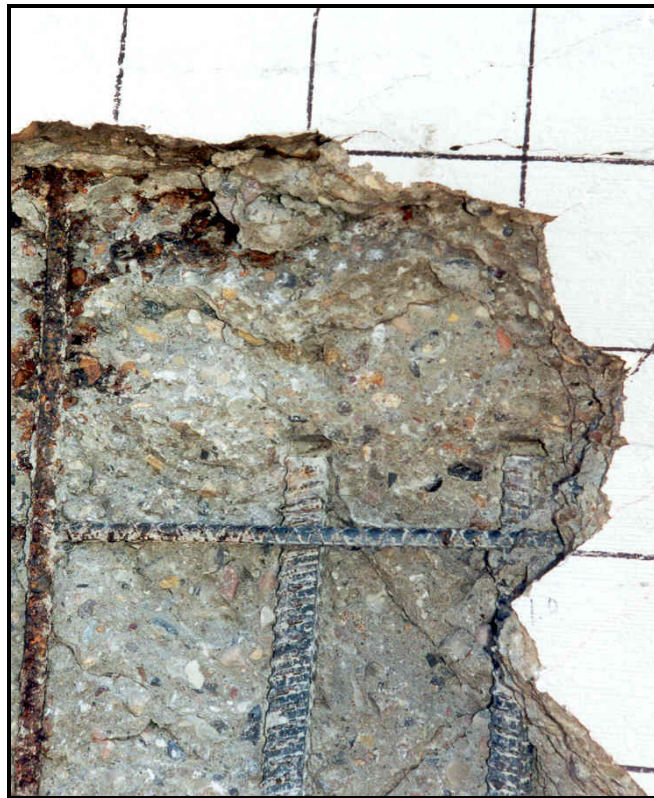
Figure 2.50 22mm long pullout pocket in column longitudinal bars at West column-bent cap joint

After removing the de-bonded clear cover the column longitudinal reinforcement on the south face, the column longitudinal rebar had been found pulled out by 35mm, as shown in Figure 2.50.

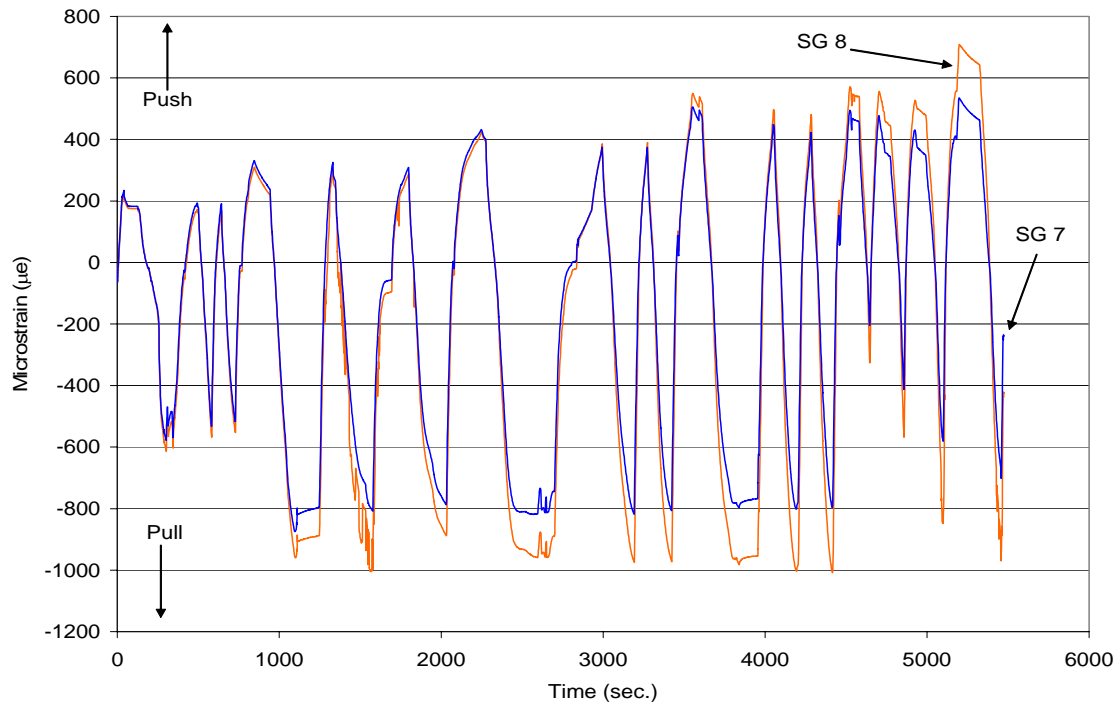
Figure 2.51 SG7 and SG 8 showing slip of lap splice in East column base

The East column base was instrumented with four strain gages located on the east face of the column 451mm above the pile cap; the strain gages are numbered SG7, SG8, SG9 and SG10, as shown in Figure 2.22. These four strain gages are strategically located as to have one gage on each bar of the lap splice that connects the column longitudinal bar to the pile cap rebar protruding through the cold joint. The intent was to have strain readings across the splice to be able to determine whether the splice was long enough to develop the tensile forces, or whether the splice would slip. As anticipated, the splice was not long enough and lap splice failure occurred. The maximum tensile strain recorded by these strain gages was $1000\mu\epsilon$, which is 83% of yield by SG8. The maximum compressive strain was from SG8 as well, and it was $700\mu\epsilon$ or 58% of yield. The results of monitoring SG7 and SG8 on two bars shows that the lap splice has two distinct strain levels that can be seen in Figure 2.51. From $0\% < \text{drift} < 0.5\%$, the strain levels are perfectly aligned. From $0.5\% < \text{drift} < 1\%$, the tensile strains lay right on top of each other, but the compression strains start to deviate. At 2.0% drift, the tensile strains start to part and the slip in the lap splice starts developing. From there on, the slip develops further and it is evident that the two bars are straining differently.

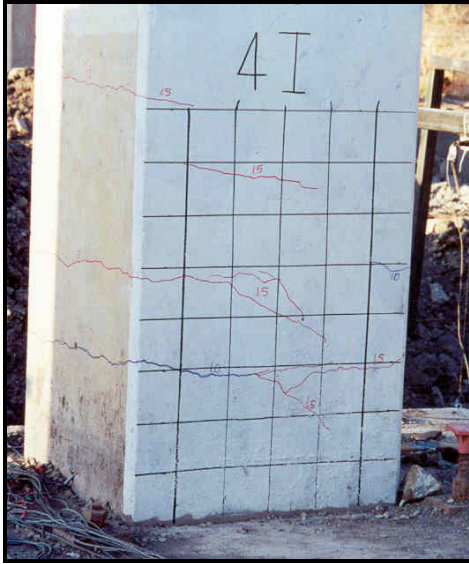
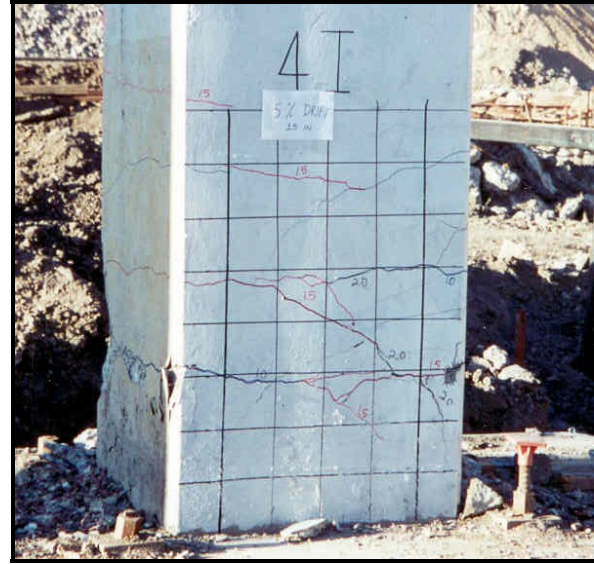
Figure 2.53 East column base: (a) 0.8mm cracks at 1.5% drift ratio, (b) 3mm to 5mm cracks at 5% drift ratio

- 1.) No visible flexural or shear cracks @ 0.5% drift
- 2.) Hairline flexural cracks start to develop at 279mm and 1.7m above the grade beam. They start in the middle of the south face and wrap around the west face and end in the center of the north face of the east column @ 1.0% drift
- 3.) 0.8mm flexural cracks propagate from hairline; @ 1.5% drift more flexural cracks appear with the half column formation mentioned above; 2.0mm cracks develop 279mm above pile cap
- 4.) 1.5mm flexural cracks open on the east half of the column 914mm above pile cap; No shear cracks have developed yet at 2.0% drift
- 5.) South face largest crack 3mm, west face largest crack 5mm, north face largest crack 3mm, east face largest crack 5mm at 5.0% drift

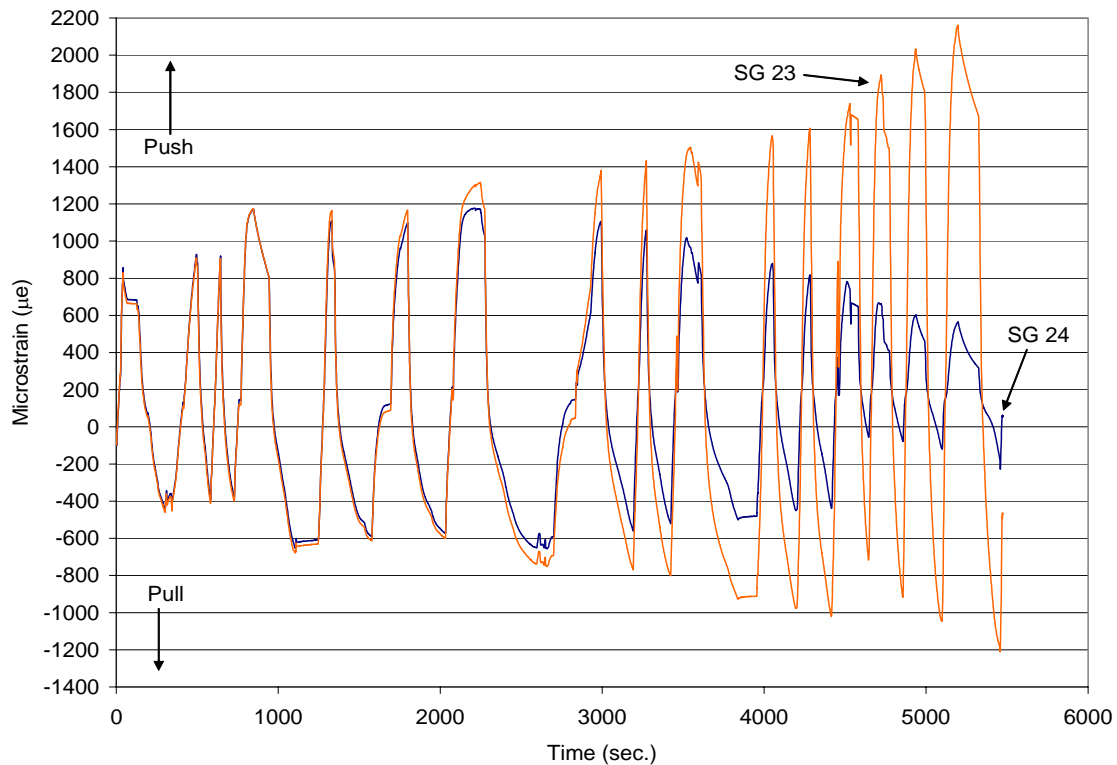
Figure 2.55 SG23 and SG24 showing relative slip in lap splice of center column base

The lap splice held together well until a 1.5% drift ratio, after which the strains started to deviate; SG23 which was attached to the column rebar did exactly what was expected as seen in Figure 2.55. In the 6th cycle, SG23 reached the yield point and continued to increase in tensile strain with each cycle; on the other hand, the lap splice bar containing SG24 almost hit yield but then experienced slip at a 1.5% drift ratio; the next couple of cycles show some slipping then at 2.0% drift the slip degrades sharply, and this continues through to 5.0% drift. Strain gage SG28 located on the hoop steel recorded only 42% of its yield strength.

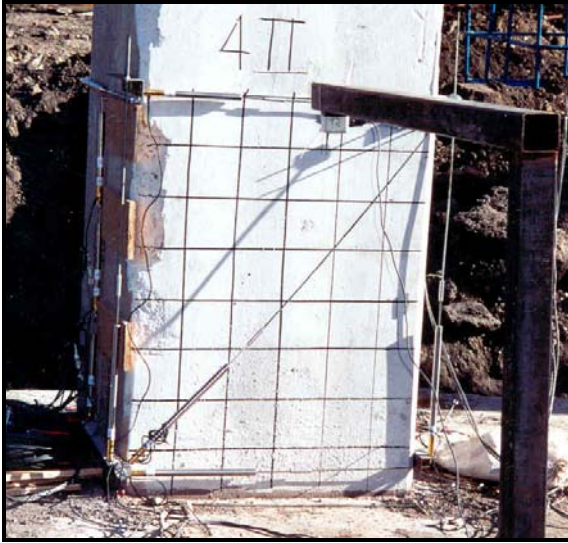
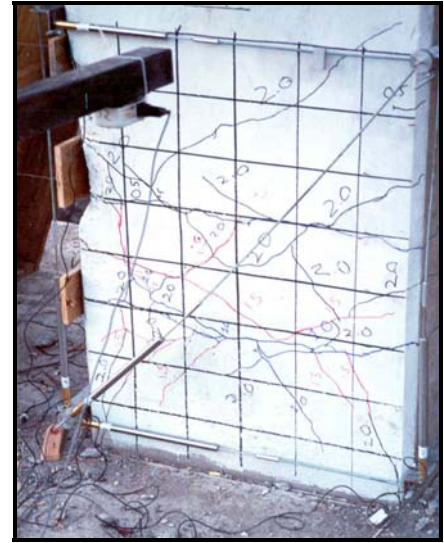
Phase I $0.5 < \text{drift} \leq 1.0$	Phase II $1.0 < \text{drift} \leq 2.0$	Phase III $2.0 < \text{drift} \leq 5.0$
Steel	n/a	SG23 yields on first 1.5% drift-push cycle at about 1.2% drift	Almost all axial bars have yielded with the exception of those close to the neutral axis on the North and South faces
Concrete	0.1mm flexural crack develops on all four sides at 762mm at 0.5% drift 1.5mm flexural/shear cracks develop between 76mm and 600mm at 1.0% drift	2.5mm flexural cracks propagate at 1.5% drift from the previous drift step; more flexural cracks appear. Flexural cracks are 3.0mm wide by end of 1.5% drift step. Shear cracks start to develop quickly from the flexural cracks at centerline of column and are 2.0mm by end of 1.5% drift step. Shear degradation is main mode of failure in the 2.0% drift step with 4.0mm shear cracks at the opening ends of the East/West faces and tapering to 1.0mm at the closing ends	Largest cracking experienced by the end of the 5.0% drift cycle was 11.0mm on South face near buckle zone of West face, 7.0mm on West face again associated with the buckle zone, 7.0mm, 16mm, and 19mm cracks on North side, see Figure 2.60(b), and 10 mm cracks on the East face along the buckle zone

Figure 2.58 Center column base: (a) before test, (b) diagonal shear cracks at 2% drift

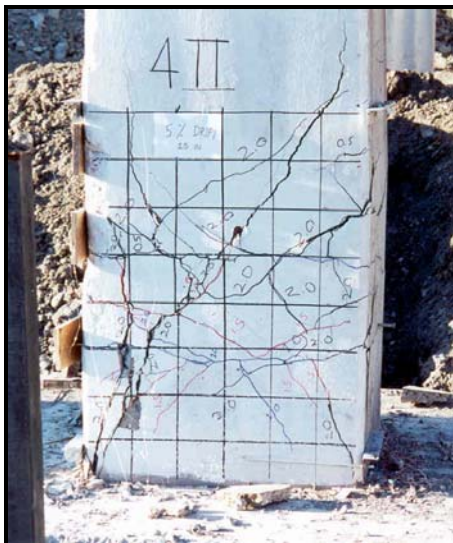
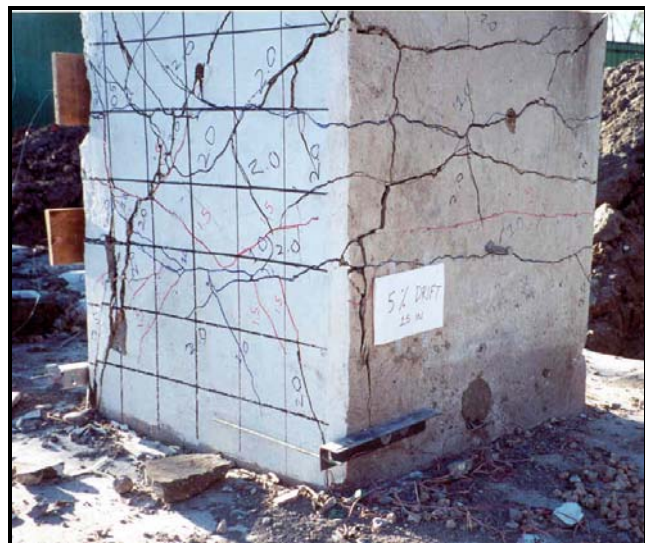
- 6.) Largest crack experienced by the end of the 5.0% drift ratio last cycle was 11.0mm on South face near the buckling zone of the west face, 7.0mm on the West face again associated with the buckling zone, 7.0mm, 16mm, and 19mm cracks on the North side, as shown in see Figure 2.60(b), and 10 mm cracks on the East face along the buckling zone

Figure 2.59 Center column base at 5% drift: (a) South face, (b) East face

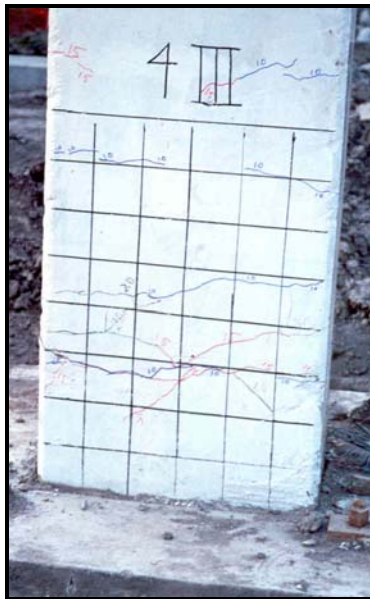
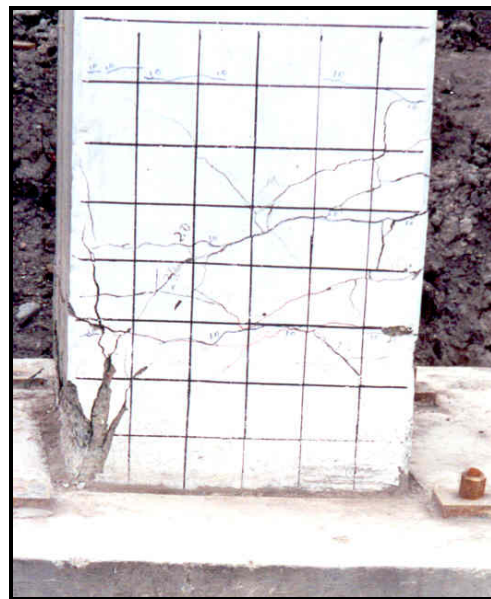
- 3.) 1.0mm flexural cracks propagate from the hairlines @ 1.5% drift in the 419mm height range
- 4.) 1.0mm flexural cracks start migrating to the corners of the column and grade beam to develop the shearing mechanism @ 2.0% drift

- 5.) A triangular chunk of concrete is cracked and hanging in place on the West face. The largest crack on the South face was 11mm, on the West face the largest crack was 4.7mm, on the North face the largest crack was 6mm, and on the east face the largest crack was 9mm at 5.0% drift

Figure 2.63 West column base damage: (a) South face at 2% drift, (b) South face at 5% drift

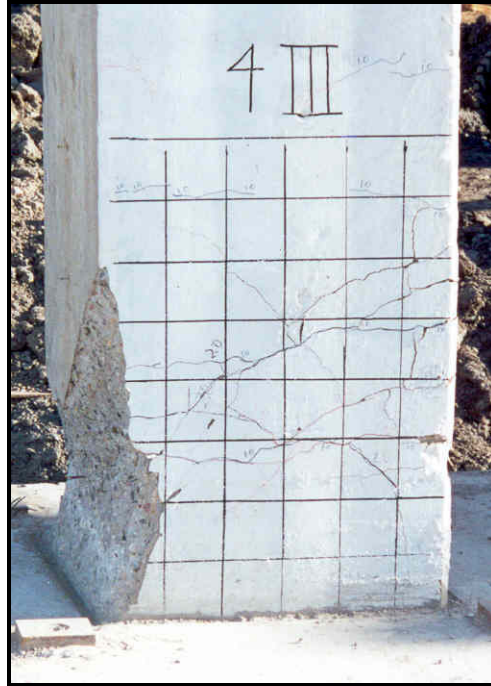
Figure 2.64 West column base post-test damage on South face at 5% drift

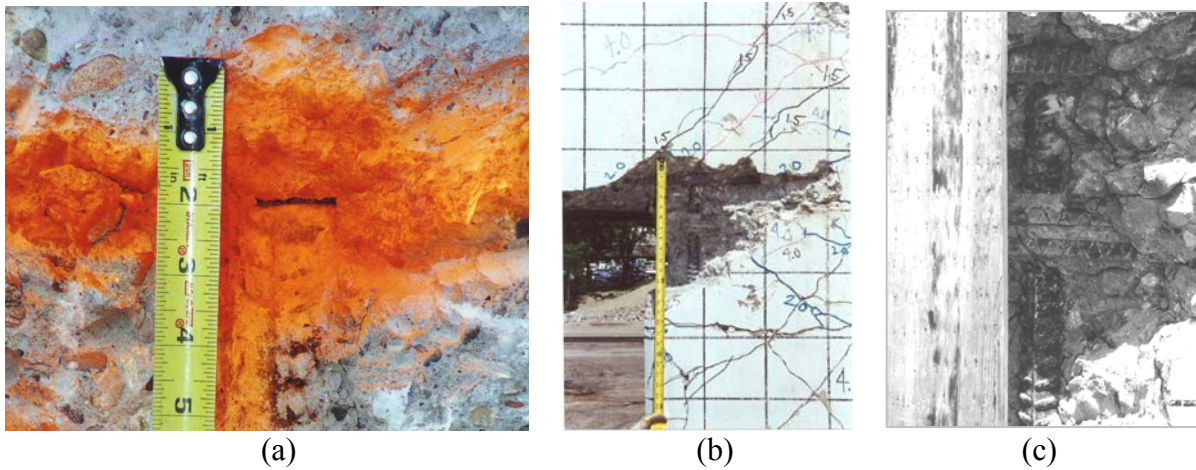
Strain gauge readings in the lap splice region of the columns, and on the longitudinal reinforcement extending into the bent cap-column joints indicated that pullout of column reinforcing bars had occurred. Insufficient anchorage causes weakening of the entire structure and a greater propensity for loss of capacity. The strain gauge reading on the longitudinal reinforcement at the column bottom was subtracted from the reading at the anchorage dowels coming up from the pile cap; this difference determined the strain at which slippage had occurred in the lap splice. As shown in Figure 3.18, at a drift ratio of 2%, the center column lap splice began slipping at a differential strain of 1 mm/m (or a strain of 1.4 mm/m in the column bars); this slip gradually increased causing a drop in the structure's strength. It is obvious that a 24 bar diameter splice is not effective.

Similarly, at the top of the columns, the column longitudinal reinforcement started losing anchorage in the bent cap-column joint at a strain from 1.2 mm/m to 1.6 mm/m and a drift ratio of 2.0%. A 3 mm pullout of the longitudinal reinforcement at the top of the east column was observed at completion of the test, as shown in Figure 3.19a; the damage at the top of the center column at termination of the test is shown in Figure 3.19b and 3.19c, which included bar buckling. This indicates insufficient anchorage of the column bars in the bent cap, since no transverse reinforcement was provided in the bent cap column joint; insufficient anchorage of column bars is a known deficiency of older bridges (Park et al. 1993).

Figure 3.19 Damage to Bent #5S (2000) at top of center column: (a) pullout of longitudinal reinforcement, (b) after test, (c) showing buckled column bar

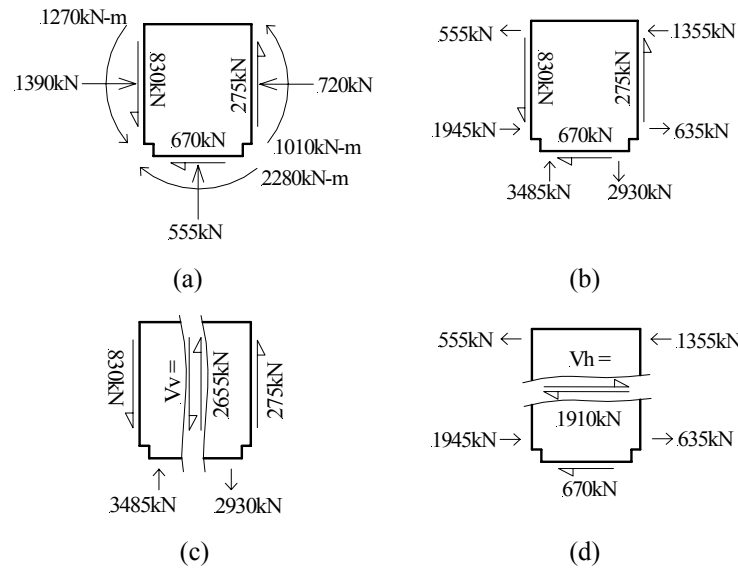
where V_v = vertical shear force (2655 kN), V_h = horizontal shear force (1910 kN), A_{jv} = vertical joint area (1.115 m²), and A_{jh} = horizontal joint area (0.836 m²). The vertical and horizontal shear stresses were found from Equation 3.10 as 2.38 MPa and 2.28 MPa, respectively. From Equation 3.9, the nominal joint shear stress was 2.33 MPa or $0.40 \sqrt{f'_c}$.

Figure 3.20 Nominal joint shear in center cap-column joint: (a) free-body diagram, (b) forces resolved into couples, (c) vertical shear, and (d) horizontal shear

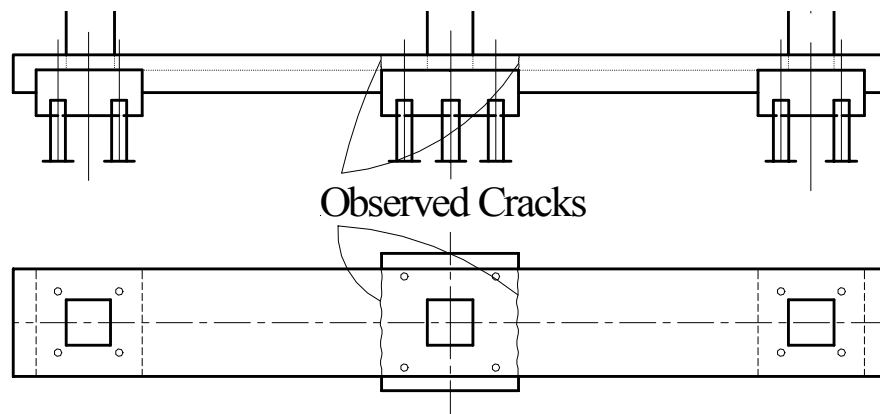
unit. However, the negative moment near the center pile cap was 33% higher than the capacity, causing the grade beam to undergo flexural stresses and deformations high enough to induce cracking. These cracks developed in the grade beam overlay at a 2.5% drift ratio above the vertical faces of the existing pile cap, on both sides of the center column, as shown in Figures 3.22 and 3.23.

Figure 3.23 Location of observed cracks in the grade beam

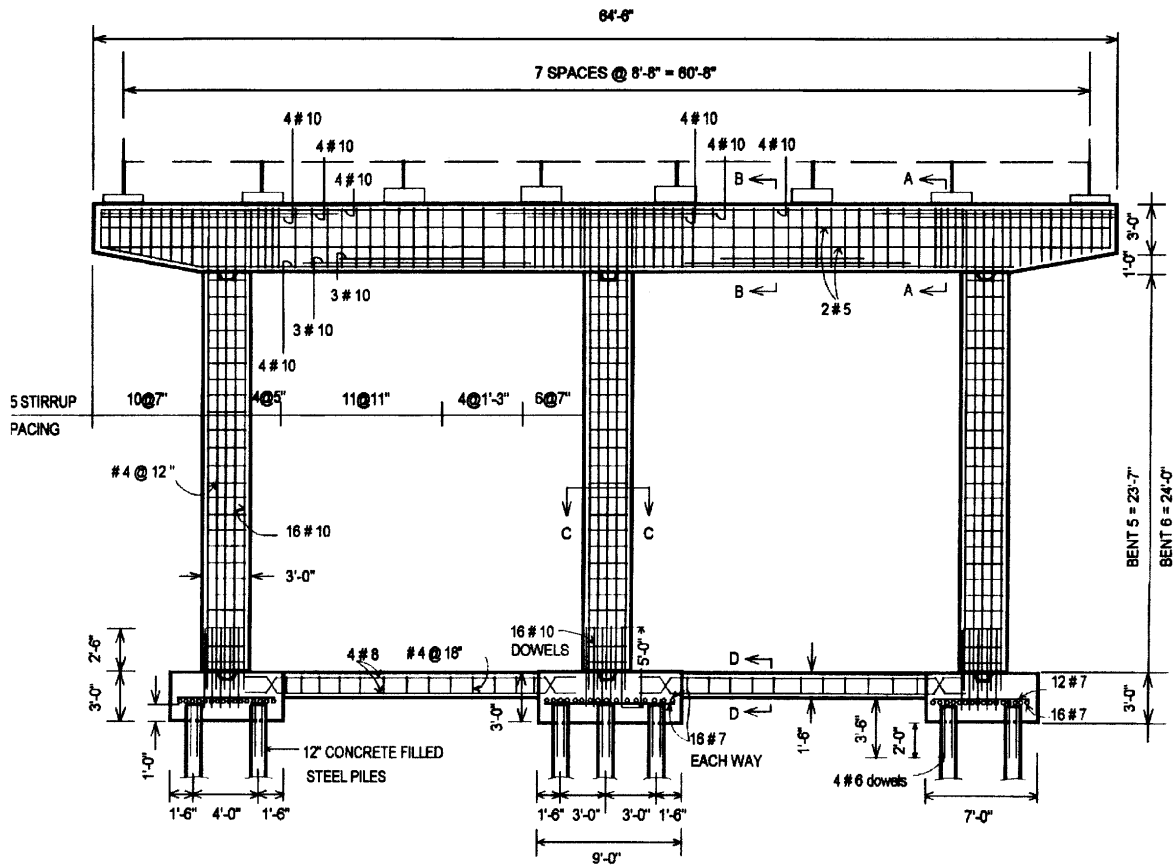
An assessment of the original reinforcement details showed that there were four reinforcement deficiencies in the original 1962 steel details. The first deficiency was an inadequate amount of longitudinal reinforcement in the lap splice regions located at the base of the columns. Second, there was inadequate anchorage of the longitudinal steel in both the pile cap and cap beam. Third, there was no transverse hoop steel in the column-cap beam joints. Finally, the confining steel in the columns was not sufficient by today's codes. The as-built reinforcement details are as shown in Figures 4.7 and 4.8. There was one variation in

Figure 4.7 Elevation showing the original 1962 steel details

total displacement and the 16mm gap found in the joint region was 36mm. The additional 36mm displacement came from two conditions: yielding of the longitudinal bars in the column, at the plastic hinges, and slippage of the 0.76 m length longitudinal stub-in reinforcement in the lap splice located at the bottom of the column, shown in Figure 4.7.

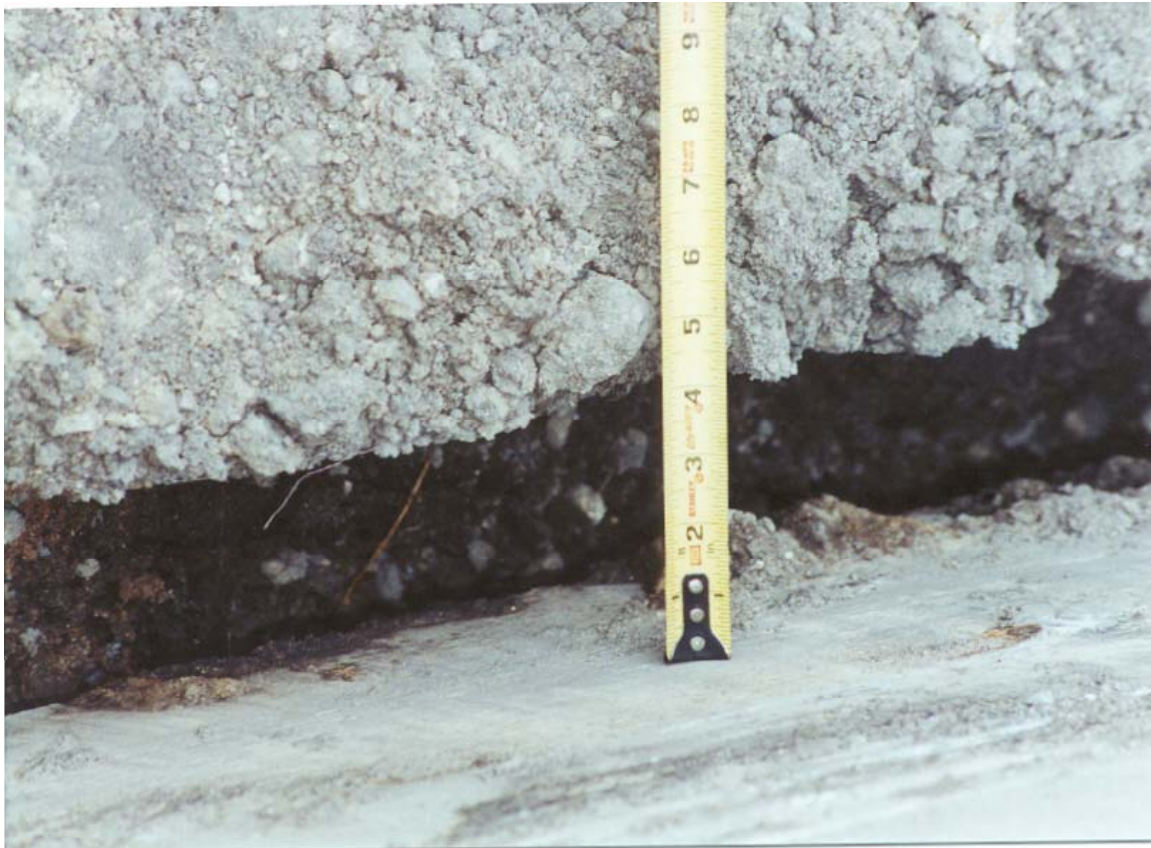
foundations, and stretching in tension cables during the pull portion of each cycle. A picture of the ultimate lateral displacement (102 mm) of the load frame foundation for the Bent #6S 2000 test is shown in Figure 4.40.

Figure 4.40 Horizontal displacement of load frame foundations (102 mm) on Bent #6S (2000)

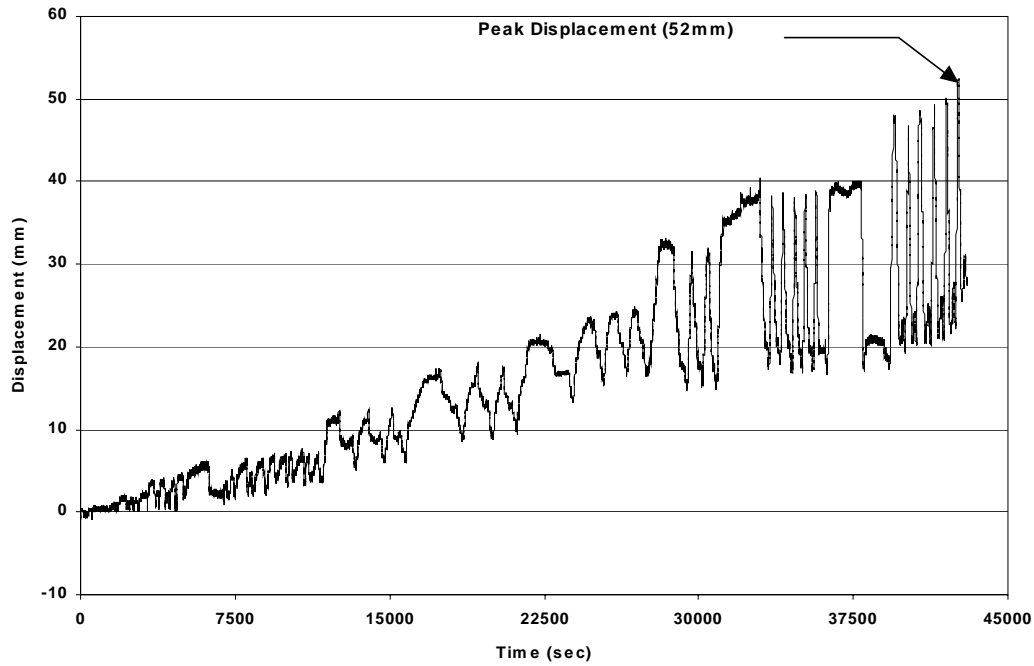
The total vertical displacement, from DT 8 and 2, for the West column of the superstructure was 52 mm as shown in Figure 4.45. The displacement difference between the

Figure 4.45 Total permanent vertical deformation of the superstructure on the West column Bent #6S 2000 test on (DT 8) and (DT 2), Saturday 6 May 00 and Tuesday 9 May 00

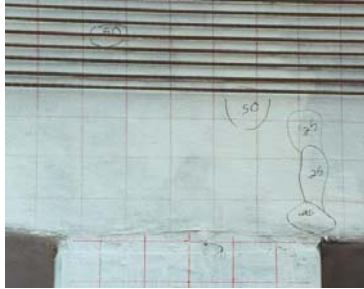
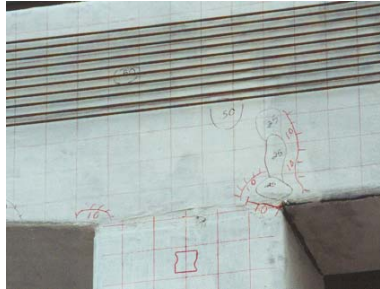
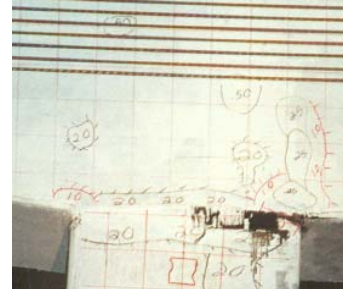
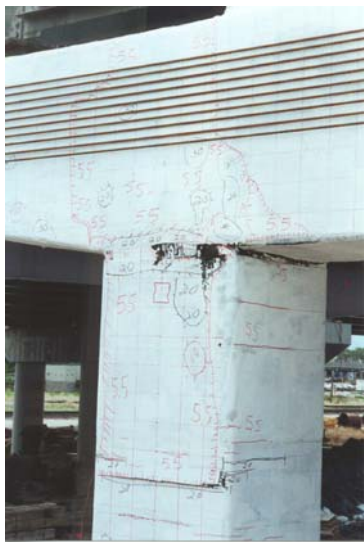
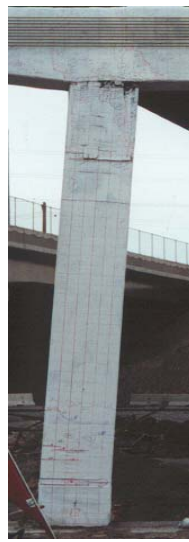
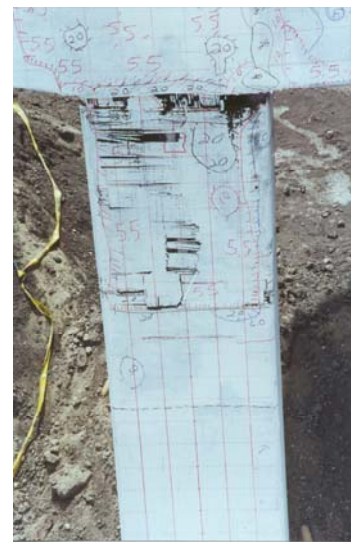
Figure 4.88 Surface damage for East column-cap beam joint

Phase I $0 \leq \text{time} \leq 3,000$ $0\% \leq \text{drift} \leq 0.5\%$	Phase II $3,000 \leq \text{time} \leq 17,000$ $0.5\% \leq \text{drift} \leq 3.8\%$	Phase III $17,000 \leq \text{time} \leq 25,500$ $3.8\% \leq \text{drift} \leq 5.5\%$	Phase IV $\text{time} \geq 3,000$ $\text{drift} \geq 5.5$
Ankle Wrap or Diagonal Layers	Min. delaminating of layers. See Figure 4.88(a)	Additional delaminating added to Phase I. See Figure 4.88(b)	Additional delaminating added to Phase II. See Figure 4.88(c)	Additional delaminating to phase III. See Figure 4.88(d)
Zero Layers	No loss in tensile capacity. See Figure 4.88(a)	No loss in tensile capacity. See Figure 4.88(b)	No loss in tensile capacity. See Figure 4.88(c)	No loss in tensile capacity. See Figures 4.88(e) and 4.88(f)
U-Strap Layers	Small amount of delaminating. See Figure 4.88(a)	Drift 3.73% is the beginning point of the U-strap fracture. See Figures 4.88(b) and 4.88(c)	Fracture of U-strap due to excessive bending moment and tensile force on west strap. See Figure 4.88(c)	Complete U-strap failure. See Figures 4.88(d) through 4.88(f)

Confinement Layers	No lateral flexural cracks formed in CFRP composite layers	Lateral flexural cracks in confinement layers begin approximately 1.0% drift	Lateral flexural cracks do not increase after U-straps begin to fail and rotation is transferred to the bottom grade beam joint	Lateral flexural cracks do not increase after U-straps begin to fail and rotation is transferred to the bottom grade beam joint
Longitudinal Bar Yielding	No yielding. See Figure 4.88(a)	All yielding occurred in phase II. See Figure 4.80	1) West face column bars slightly buckle from confinement layers delaminating. See Figures 4.89(g) and 4.89(h). 2) Longitudinal reinforcement steel begins to de-bond at approximately 5.5% See Figure 4.89(c)	Longitudinal bars have de-bonded See Figure 4.89(c)

(a) $0\% \leq \text{drift} \leq 0.5\%$

(b) $0.5\% \leq \text{drift} \leq 3.8\%$

(c) $3.8\% \leq \text{drift} \leq 5.5\%$

(d) drift $\approx 5.5\%$

(e) drift $\approx 6.5\%$

(f) after 6.8% drift

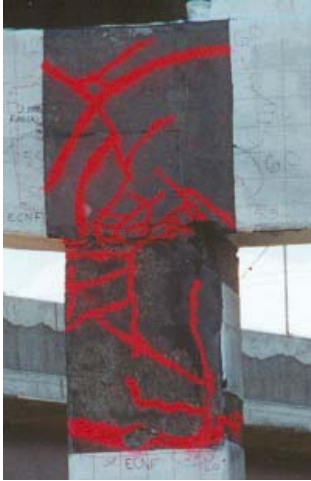
(a) Joint radial shear crack

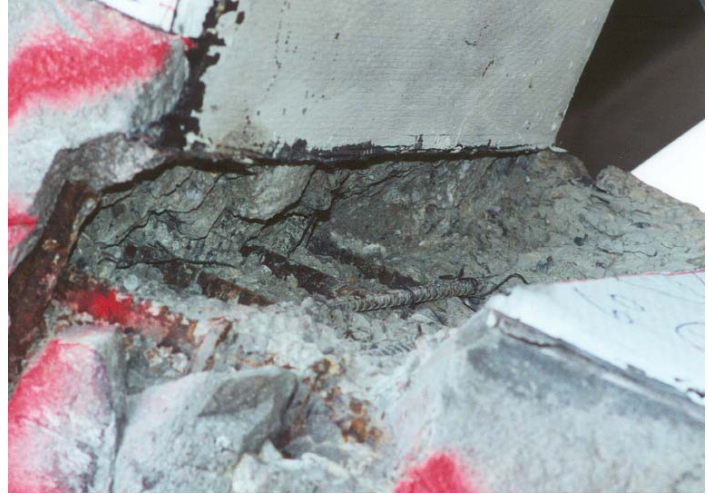
(b) Longitudinal reinforcement bar buckle

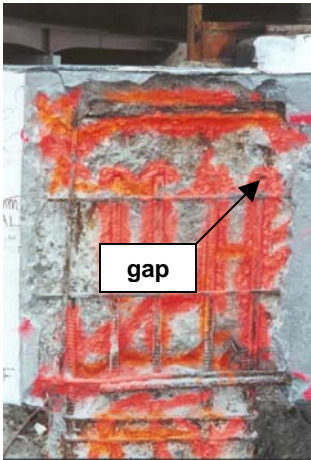
From onsite field observations after the CFRP composite layers were removed, it was noted that there was a 4.8 mm gap at the top of the column longitudinal steel. The column longitudinal steel debonded at approximately 5.0% displacement drift. The loss of longitudinal reinforcement steel bond strength occurred in the West column-cap beam joint at approximately the same displacement drift.

(c) Reinforcement bar de-bonded

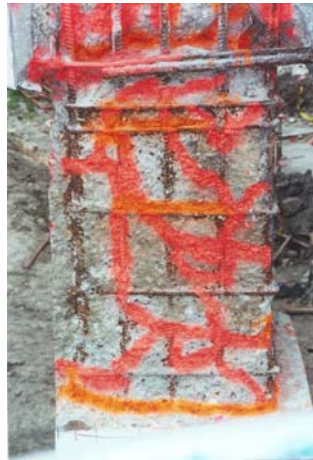
(d) Column flexural and shear cracks

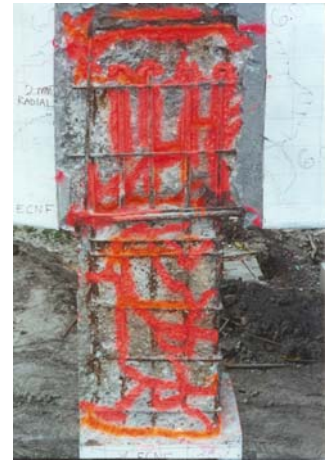
(e) North face of East joint

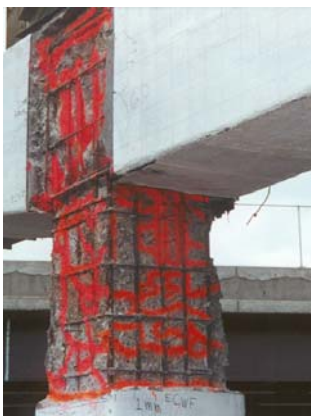
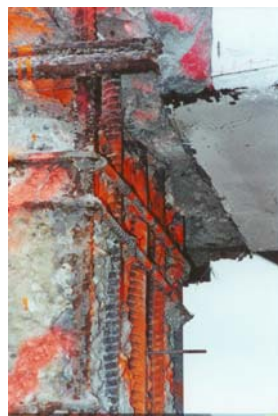
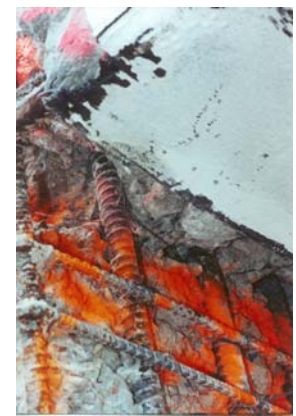
Figure 4.89 Internal damage for East column-cap beam joint

(f) West face of East joint

(g) West face reinforcement bar buckle

(h) West face buckle

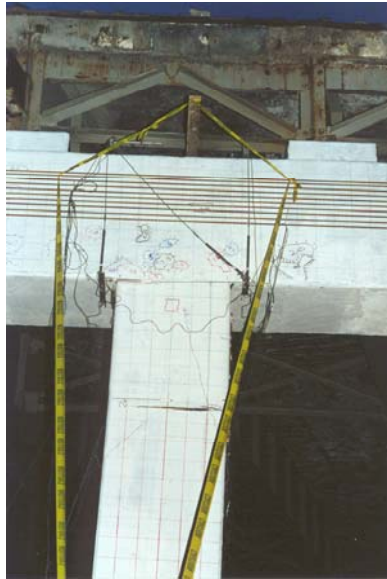
longitudinal reinforcement. Strain gage 44 was placed approximately 305mm below the cap beam soffit in the West face of the middle column and SG 45 was placed approximately in the middle of the Middle joint in both the horizontal and vertical directions, as shown in Figure 4.28. The high strains recorded in strain gage SG44 concurs with Figure 4.90 showing large flexural damage sustained in the middle column plastic hinge region. Strain gage SG44 had the highest tensile and compressive strains and was the only gage out of the four internal strain gages that yielded. Its recorded maximum tensile and compression strains were 149% and 80% of the reinforcement steel yield strain, respectively. From Figure 4.95, it can be seen that there is no damage to the U-straps, but below the six-column confinement layers that lay adjacent to the beam cap soffit, the top portion of the column degraded due to the high flexural demands that were applied to the plastic hinge region of the column.

Figure 4.95 Excessive flexural demands applied to the upper column confinement layers adjacent to the cap beam soffit
